## Windscreen repair. What is covered?

## Tyre Repair. What is covered?

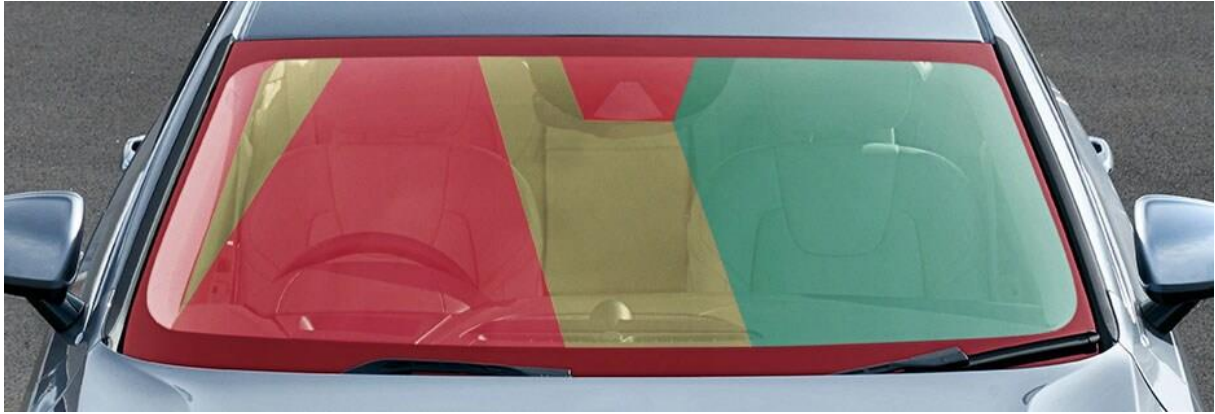
Windscreen repairs, for Volvo cars only, will be assessed initially to establish that the damage is repairable as stipulated by Volvo Safety Standards:

- Red Zone: Repairs cannot be carried out
- Yellow Zone: Repairs for damage a maximum of 15mm in diameter
- Green Zone: Repairs for damage a maximum of 25mm in diameter
- A repair must be a minimum of 100mm distance from any other repair
